24 de enero de 2020

Re: Evaluación Estructural – Estación de Campo El Verde (Stream House)

ATC-20 Rapid Evaluation Safety Assessment Form

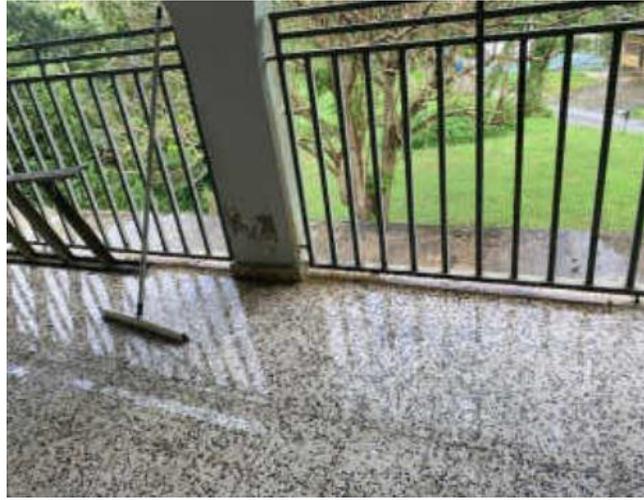
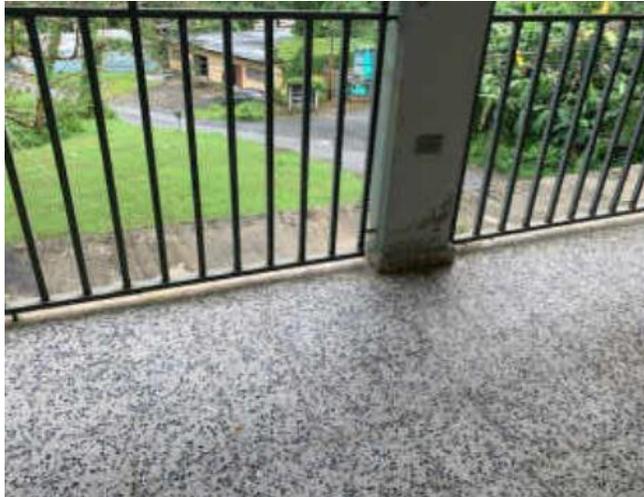
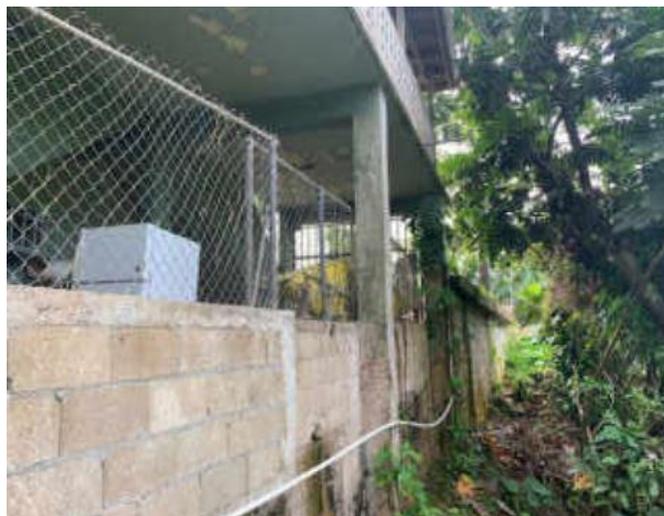
Figura 1. Fotos de Columnas

Favor ir a la **Figura 1** para ver fotos de columnas.

Se recomienda realizar una evaluación estructural de capacidad de las columnas incluyendo pruebas no destructivas para determinar refuerzo y resistencia del hormigón.
